Bray, J. D. "Developing Mitigation Measures for the Hazards Associated with Earthquake Surface Fault Rupture," in A Workshop on *Seismic Fault-Induced Failures – Possible Remedies for Damage to Urban Facilities*, Research Project 2000 Grant-in-Aid for Scientific Research (No. 12355020), Japan Society for the Promotion of Science, Workshop Leader, Kazuo Konagai, University of Tokyo, Japan, pp. 55-79, January 11-12, 2001 [Invited Paper].

# DEVELOPING MITIGATION MEASURES FOR THE HAZARDS ASSOCIATED WITH EARTHQUAKE SURFACE FAULT RUPTURE

Jonathan D. Bray

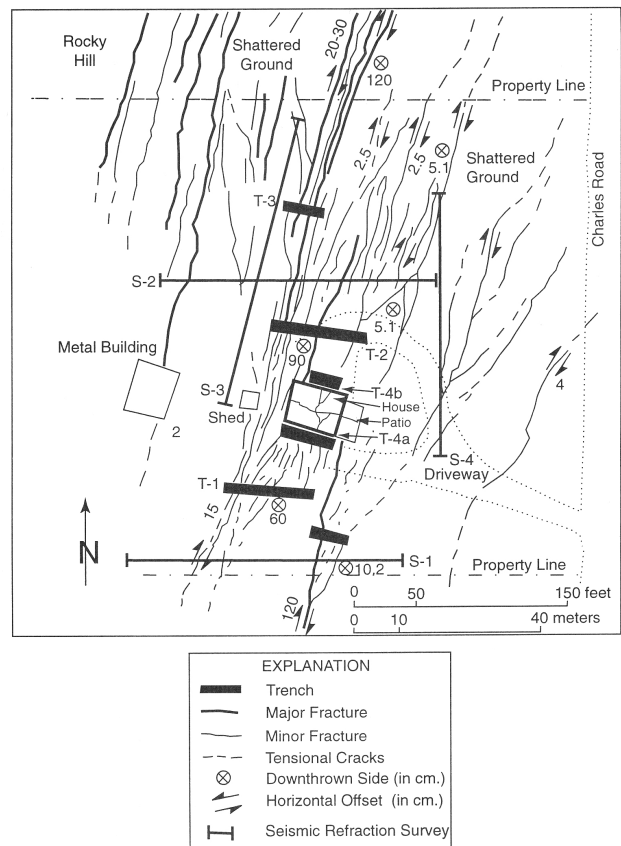
**Figure 5** Ground ruptures and exploration locations at Lannom residence at northern end of the Kickapoo stepover (after Murbach et al. 1999).

Several structures that were damaged by surface faulting were studied after the 1992 Landers Earthquake (Murbach et al. 1999). An example of a house impacted by surface faulting is shown in **Figure 5**. This is a remarkable case history, because fault trenches were excavated along the building foundation, which clearly showed how the underlying ground ruptures damaged the overlying building foundation. The building foundation condition was assessed through mapping and a floor elevation survey using a manometer (**Fig. 6**). Even though the western part of the house was closer to the main fault trace and overlaid larger ground fractures, it received less damage. It appears that damage was limited due to a plastic sheet (Visqueen) underneath it that decoupled the foundation slab from the intense ground shearing underlying it. The plastic sheet limited the transfer of horizontal strain in the ground below the foundation to the slab, keeping the foundation slab in tact. Conversely, the other slab, which was not underlain by a plastic

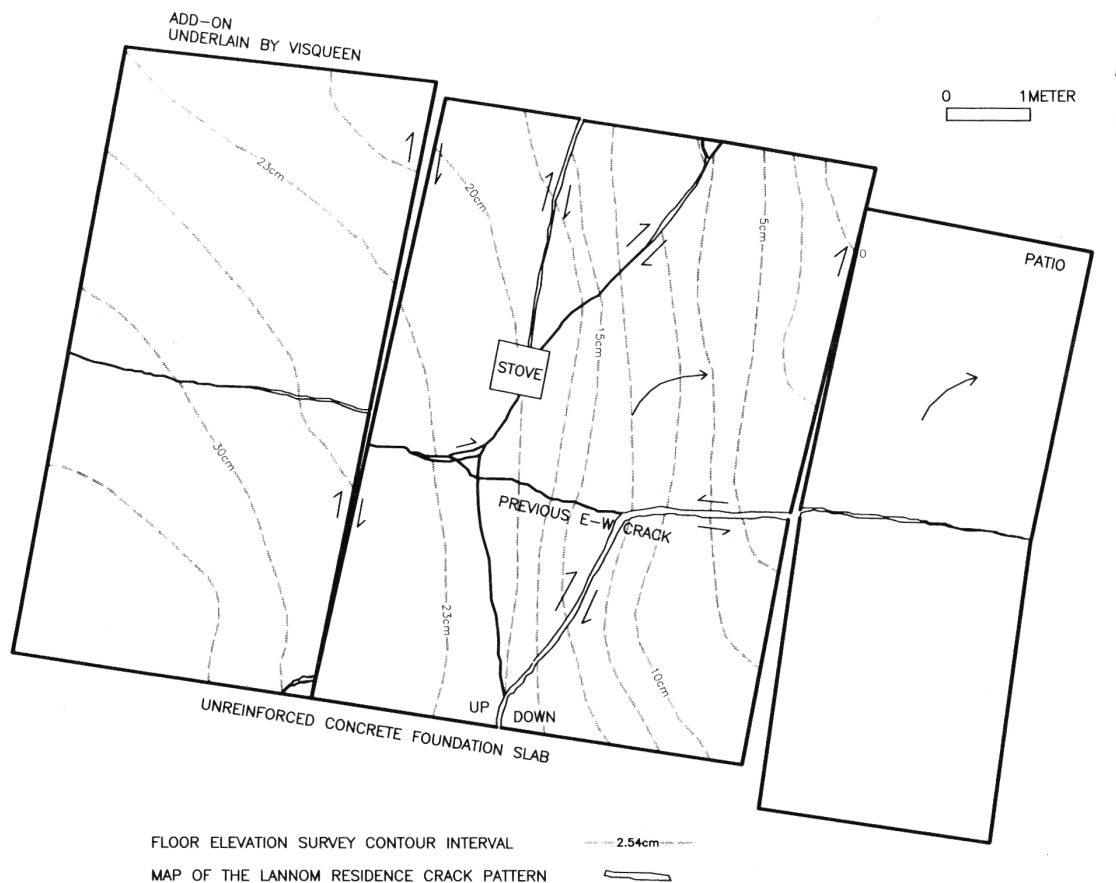
**Figure 6** Deformation of foundation slab of Lannom residence. Left unreinforced concrete foundation slab is underlain with plastic (Visqueen) and right foundation slab is not underlain with plastic. Primary fault scarp is to the left of this building (after Murbach et al. 1999).

sheet, was broken into several discrete blocks due to the nearly complete transfer of horizontal strain through the sandy soils below the foundation. Some horizontal shears were observed in the sand below the foundation, indicating that the soil began to fail as the ground deformation increased and the full strength of the sand stratum was mobilized. The weaker interface strength of the plastic allowed decoupling at an earlier stage of deformation than that in the sand stratum without the plastic sheet. The plastic decoupling layer “shielded” the overlying structure from some of the underlying ground strain.

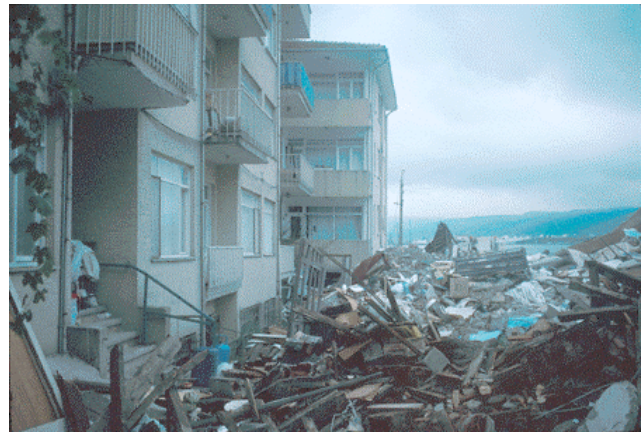
**Figure 7** Apartment house shown on right side of photo, which collapsed due to surface rupture. Fault passes across the middle of the photo between the two standing apartment houses; the far apartment house has been offset about 3 m from its original alignment with the near apartment house (Photo by F. A. Swan from Lettis et al. 2000).

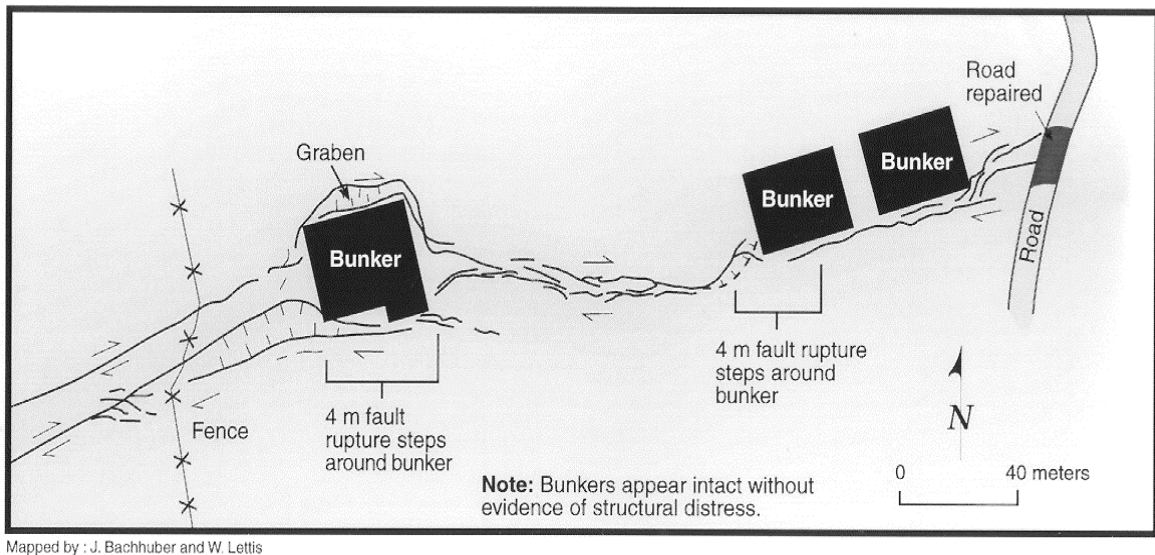
**Figure 8** The stiff concrete bunkers shown in this map were not damaged by the surface fault rupture that was diverted around them (Mapped by J. Bachhuber and W. Lettis; from Lettis et al. 2000).

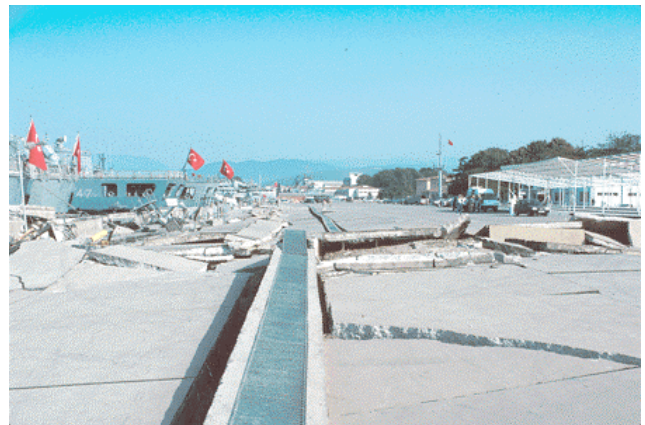
**Figure 9** Fault offset of about 2 m heavily damaged this dock at the Gölcük Naval Base, which was fixed to the ground with piling (Photo by F.A. Swan; from Lettis et al. 2000).

members to weaker connections, joints, or elements of the docks, or was accommodated by global rotation, thereby spreading the damage over a wider area (**Fig. 9**).

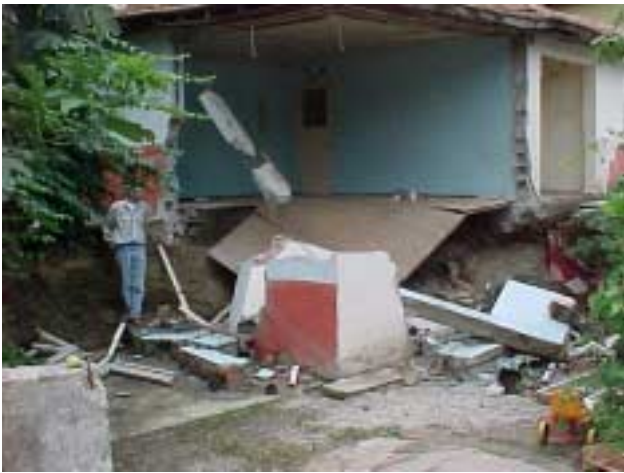
The Gölcük pull-apart basin is formed due to the right-releasing stepover between the Gölcük and Sapanca fault segments. Surface fault rupture in this area was expressed by up to 2.4 m of vertical displacement along a normal fault through the city with widespread tectonic subsidence of the basin, which caused inundation along the coast. Several structures overlying the dip-slip fault displacement were heavily damaged due to extreme differential vertical ground movements (**Fig. 10a**). Approximately

**Figure 10** (a) Extreme differential ground movement as a result of normal faulting in Golcuk destroys this apartment building; whereas, (b) apartment building that is located just off of fault scarp was not damaged, (Photos by J. D. Bray).

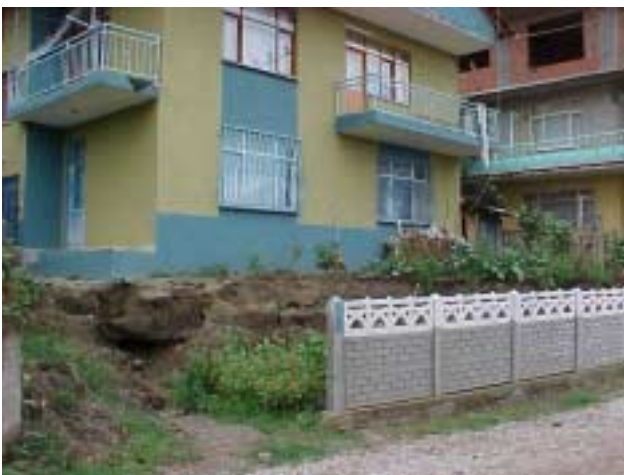
(b)

2.4 m of vertical displacement occurred within 1 m of a two-story concrete frame apartment building that was undamaged by fault rupture or by strong ground shaking (**Fig. 10b**). There were other cases of buildings in Gölcük located adjacent to the main trace which were only lightly damaged. However, buildings crossing the main trace often collapsed and some buildings located in subsidiary fault zones were heavily damaged by fault movement, such as a large assembly facility at the Ford-Otosan Plant.

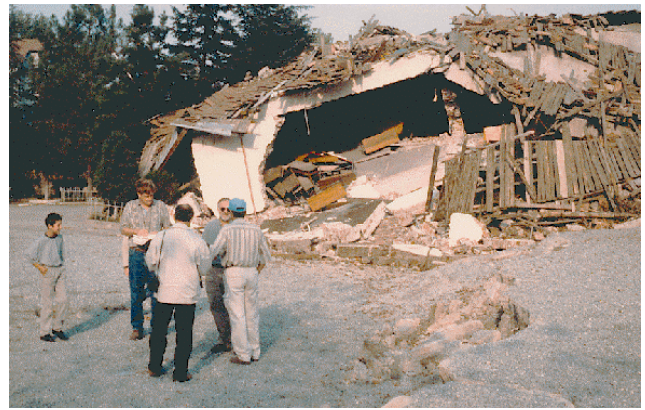
**Figure 11** Fault rupture destroyed a primary school building in Kullar (Photo by L.S. Cluff; from Lettis et al. 2000).

0.5 m of vertical displacement caused partial collapse of the town's primary school (**Fig. 11**). Strong ground shaking did not significantly damage surrounding buildings; thus, collapse of the primary school was most likely due to fault rupture. On the adjoining fault trace, about 1 m of lateral displacement directly intersected a two-story building. Displacement on the fault stopped at the building and slip was transferred to an adjoining, sub-parallel fault trace. About 1 km west of Lake Sapanca, the fault rupture directly intersects a school building (**Fig. 12**). About 1 to 2 m of distributed fault rupture was arrested by the building and forms a left en-echelon step around the building. The building foundation and walls were not damaged by the fault rupture.

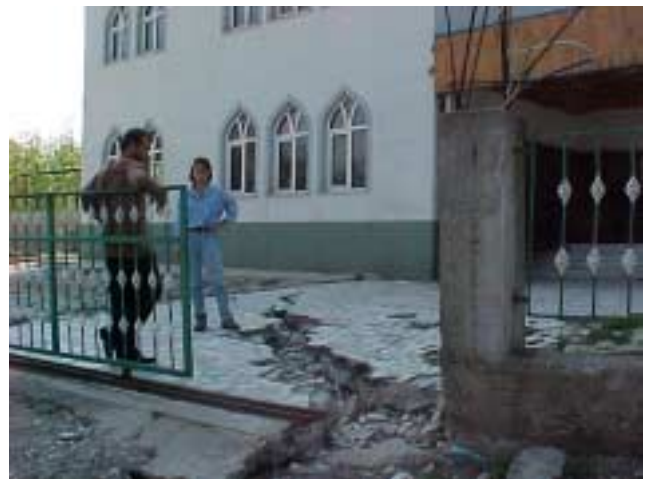
**Figure 12** Fault traversing beneath the corner of the Koran School, yet the school underwent only minimal damage (Photo by E. Rathje).

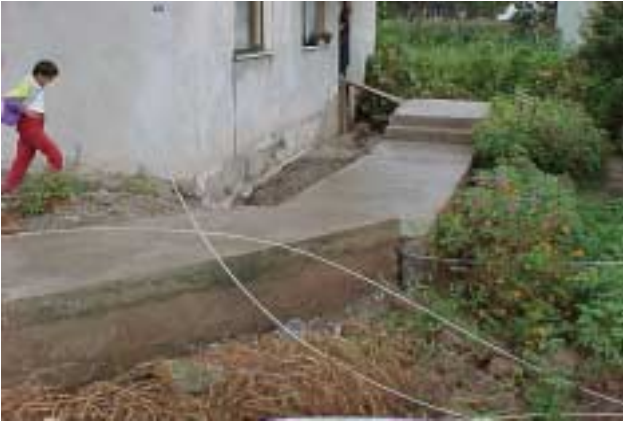
**Figure 13** Well-built 2-story house in Arifiye is not damaged although the primary surface fault scarp passed beneath it with over 3 m of right-lateral displacement. In response to the underlying fault movement, the stairs leading to the house have been offset relative to the house (Photo by J.D. Bray).

Approximately 3 to 5 m of right-lateral displacement occurred on the Sakarya fault segment. Fault rupture extended through several small towns. Within the Town of Arifiye, about 3 m of fault rupture extended beneath a 2-story residential house without damaging it (**Fig. 13**). The house foundation consisted of a shallow, 1 x 1 m reinforced concrete grid. Apparently, the shallow foundation was sufficiently stiff and strong to hold the building intact and to allow the foundation to decouple from the underlying alluvial soil on the south side of the fault. The decoupled side at the building was dragged about 2 m eastward by the north side of the fault. About 1 m of lateral displacement was consumed by compression of the soil along the margins of the house.

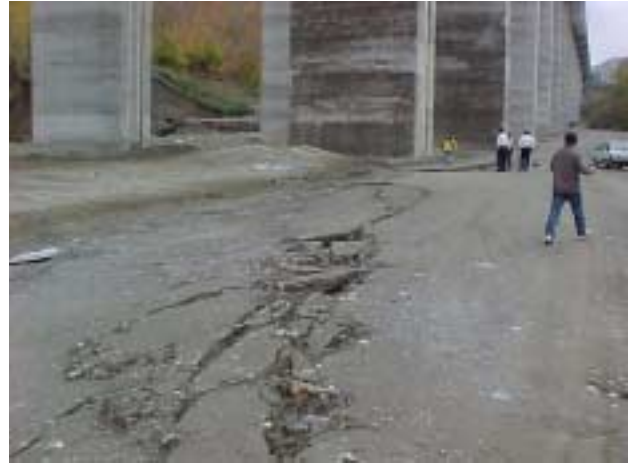
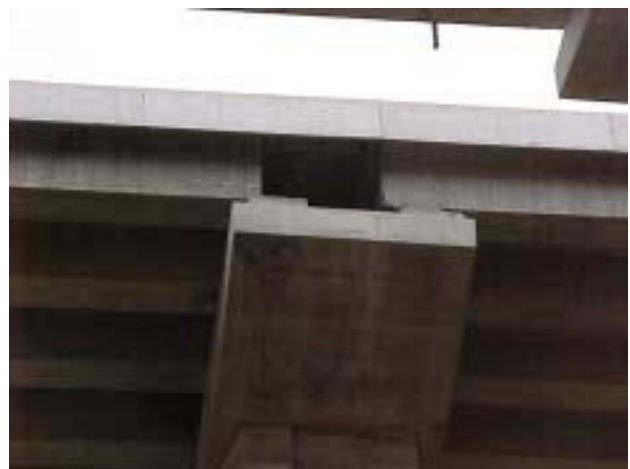
Fault rupture from the 1999 Duzce earthquake passed directly underneath the Bolu Viaduct, which is a state-of-the-art base-isolated bridge structure that was nearly complete at the time of the earthquake. Several meters of right-lateral fault displacement passed at an oblique angle through the viaduct. As shown in **Figure 14**, the ground movements rotated the pier relative to the deck it supports. The twisting of the pier foundation produced heaving of soil due to a passive earth pressure failure and ground cracking due to an active earth pressure failure on opposite corners of the foundation. The surface rupture, which followed a nearly linear path through this area, was diverted around the relatively strong embedded pier foundation. The fault rupture produced extensive damage to the viaduct, as the deck was displaced

**Figure 14** Interaction of 1999 Duzce earthquake surface fault and Bolu Viaduct: (a) several meters of right-lateral fault rupture passes at oblique angle through viaduct and directly through one pier, (b) pier is twisted as shown but is not fractured as it rotates in response to underlying fault movement. Ground rupturing is diverted around pier (Photos by J. Bray).

relative to its support. The fault movement caused the base-isolators to undergo permanent displacement, and several deck sections nearly fell from their supports.

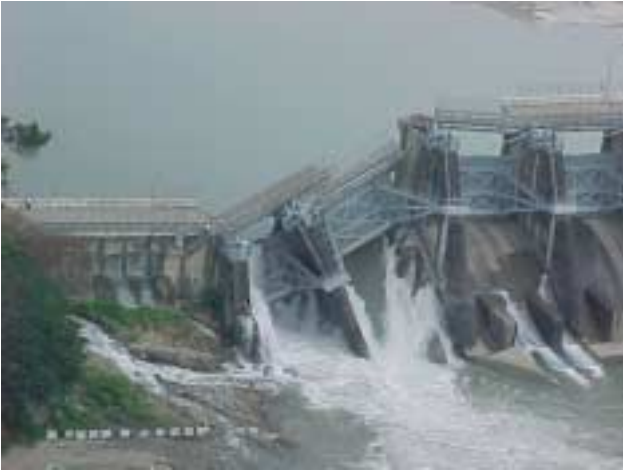
**Figure 15** View to the east of surface fault rupture through Shihkang Dam (Photo by J.D. Bray).

The fault rupture through the Shihkang Dam is a remarkable case (**Fig. 15**), because it represents the first time that a significant dam has been directly offset by primary fault rupture. A number of dams have been knowingly or unknowingly constructed atop potentially active fault traces, so this is an important case to study (Bray et al. 1992). Shihkang

Dam was offset approximately 9 m near its right abutment due to primarily dip-slip rupture. In addition, the dam crest south of the failure experienced warping associated with a broad, west-trending anticlinal axis (Lee et al. 2000). This dam did not fail catastrophically, but it did lose its function of providing water supply for the City of Taichung.

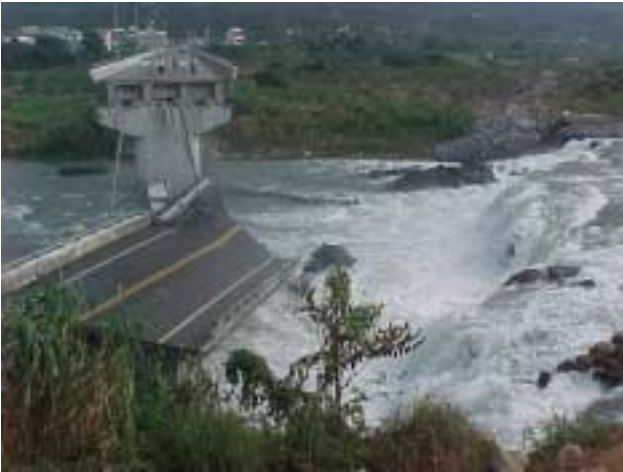
**Figure 16** Collapse of Highway 13 bridge north of Fengyuan due to 6 m fault movement (Photo by J.D. Bray).

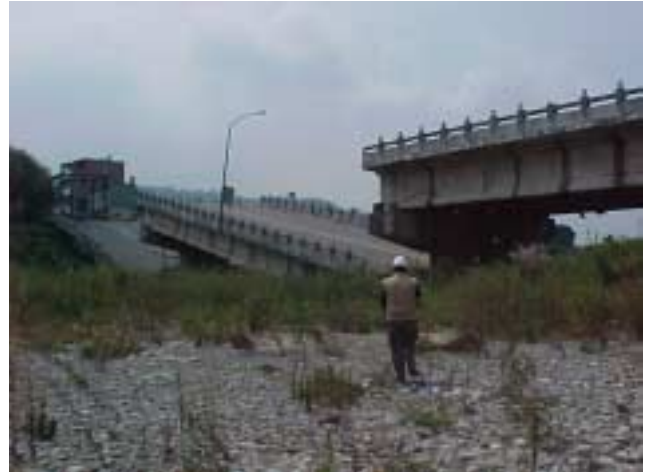
**Figure 17** Collapse of bridge directly east of Shihkang Dam due to tectonic compression (Photo by J.D. Bray).

to be two poorly expressed opposite dipping reverse faults near each bridge abutment (**Fig. 17**).

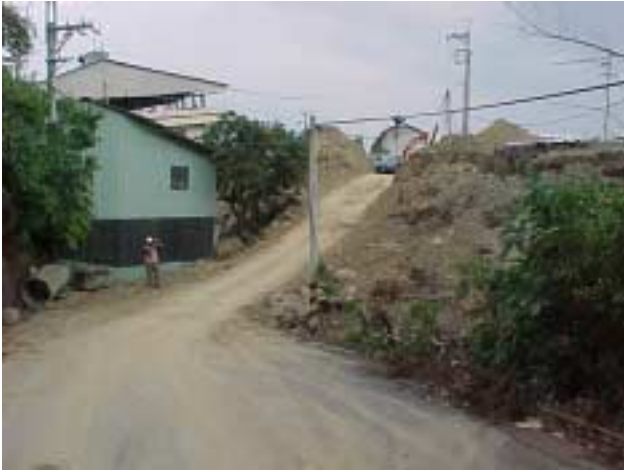
**Figure 18** Fault scarp that is about 5 m high passes close to, but does not damage, a simple steel-framed warehouse that is located on footwall side of shallow thrust fault (Photo by J. Bray).

With regard to building damage, there was relatively little differential ground deformation on the footwall block and consequently less building damage (**Fig. 18**). Those buildings that were damaged were pushed laterally when the hanging-wall thrust over the footwall, but this occurred only in close proximity of the main fault trace. Buildings straddling the fault trace underwent severe differential ground movements and were typically heavily damaged (**Fig. 19**). However, significant ground deformation expressed by warping or secondary ruptures occurred on the hanging-wall, and this damaged many buildings situated on the

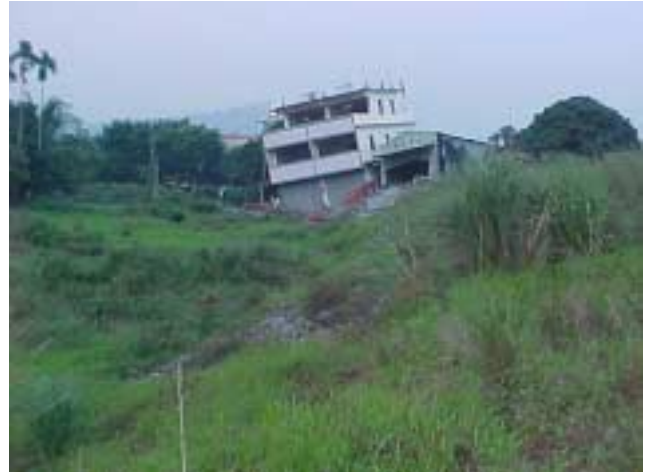
**Figure 20** North-facing subsidiary fault in hanging-wall block and local ground deformation damages this house and warehouse. This site is located southeast of Shihkang Dam and south of the primary fault ruptures running along the Tachia River in this area (Photo by J. Bray).

hanging-wall (**Fig. 20**). Ground deformation was greatest along the fault scarp and about 20 m from it on the hanging wall, but significant ground deformation was observed as much as 100 m from the fault scarp and further when back-thrust faults displaced hundreds of meters from the fault scarp on the hanging-wall block. Where the surface deformation was dominated by anticlinal folding, building damage occurred over a substantially broader area. The wider zone of severe building damage appears to be a result of the broader width of ground deformation in the hanging-wall anticline. These observations along with similar observations from other reverse fault events (e.g. Bray et al. 1994a) indicate that building zonation along reverse faults should be asymmetric, with narrow setbacks being appropriate on the footwall side and wide setbacks being necessary on the hanging-wall side.

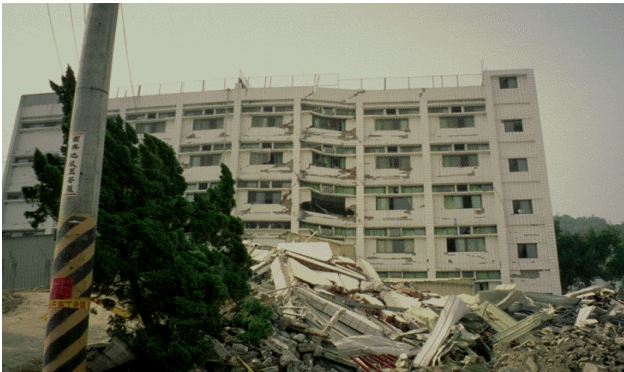
**Figure 19** The primary trace of the Chelungpu fault passed beneath this apartment building in Wu Feng, producing about 2 m of vertical displacement through the building (Photo by K. Kelson).
